The Seawall at Hawthorne Point

This report will review what is known about the seawall at Hawthorne Point. By exploring the history of the seawall, this report expresses the author's opinion that the currently damaged seawall requires reconstruction from the bedrock ledge. This report also critically examines the Notice of Intent (NOI #028-2597) and the Seawall Rehabilitation Study, rebutting key assumptions of option 1 and option 2 in the Seawall Rehabilitation Study.

During the storm of March 2, 2018, the existing seawall sustained significant damage. The essential engineering components of the Notice of Intent (#028-2597) contain sufficient contingencies that the regulatory process may not suffer significant disruption, assuming that prompt corrective action gets applied to the restoration plans.

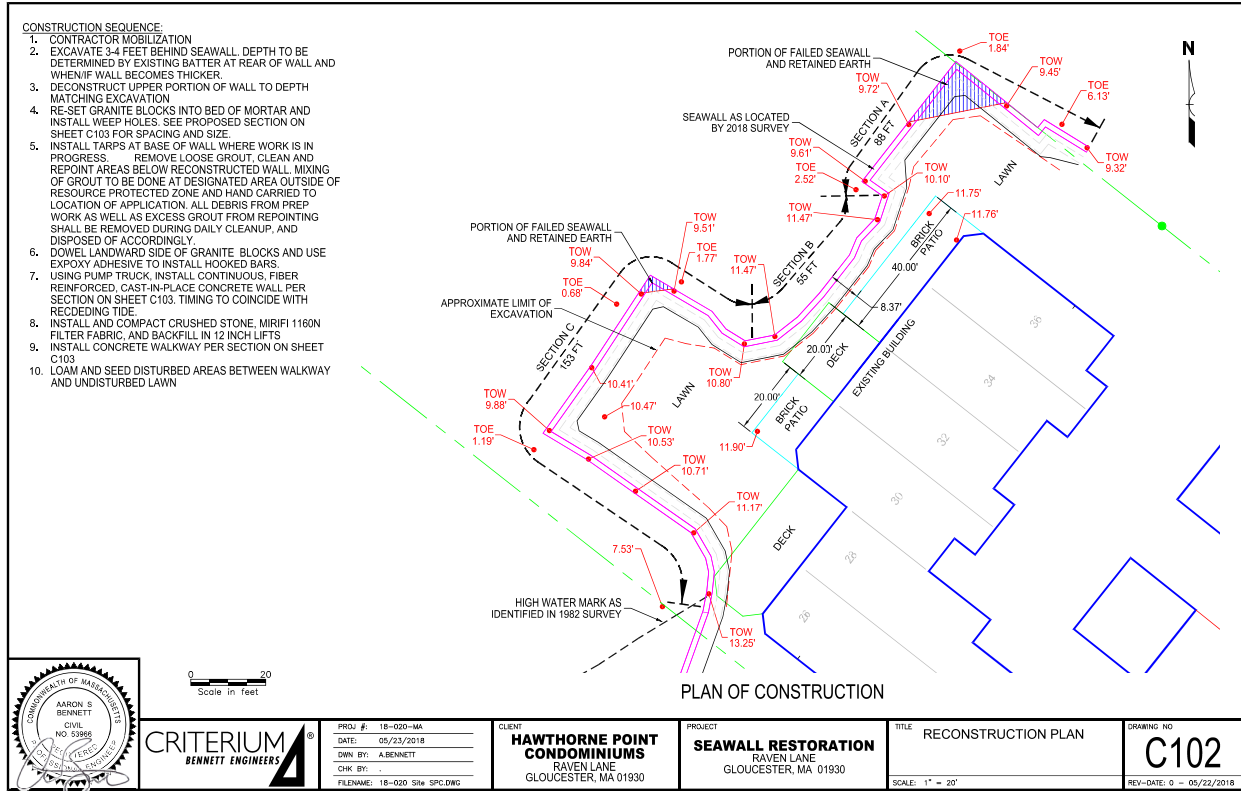
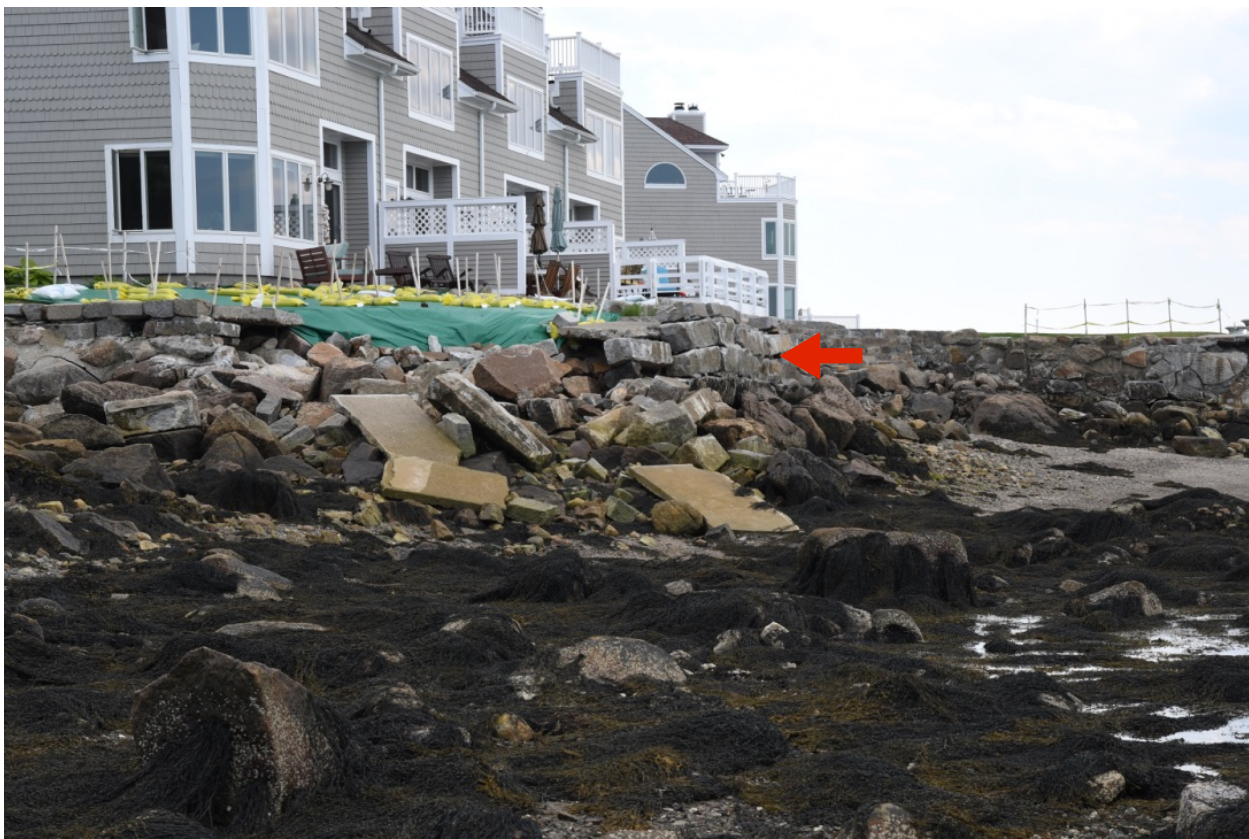
During the storm of March 2, 2018, the existing structure sustained significant damage. The Notice of Intent (NOI #028-2597) includes the following schematic drawing outlining the damaged areas. Some photos taken June 21, 2018 of section A and section C respectively help illustrate the damage.

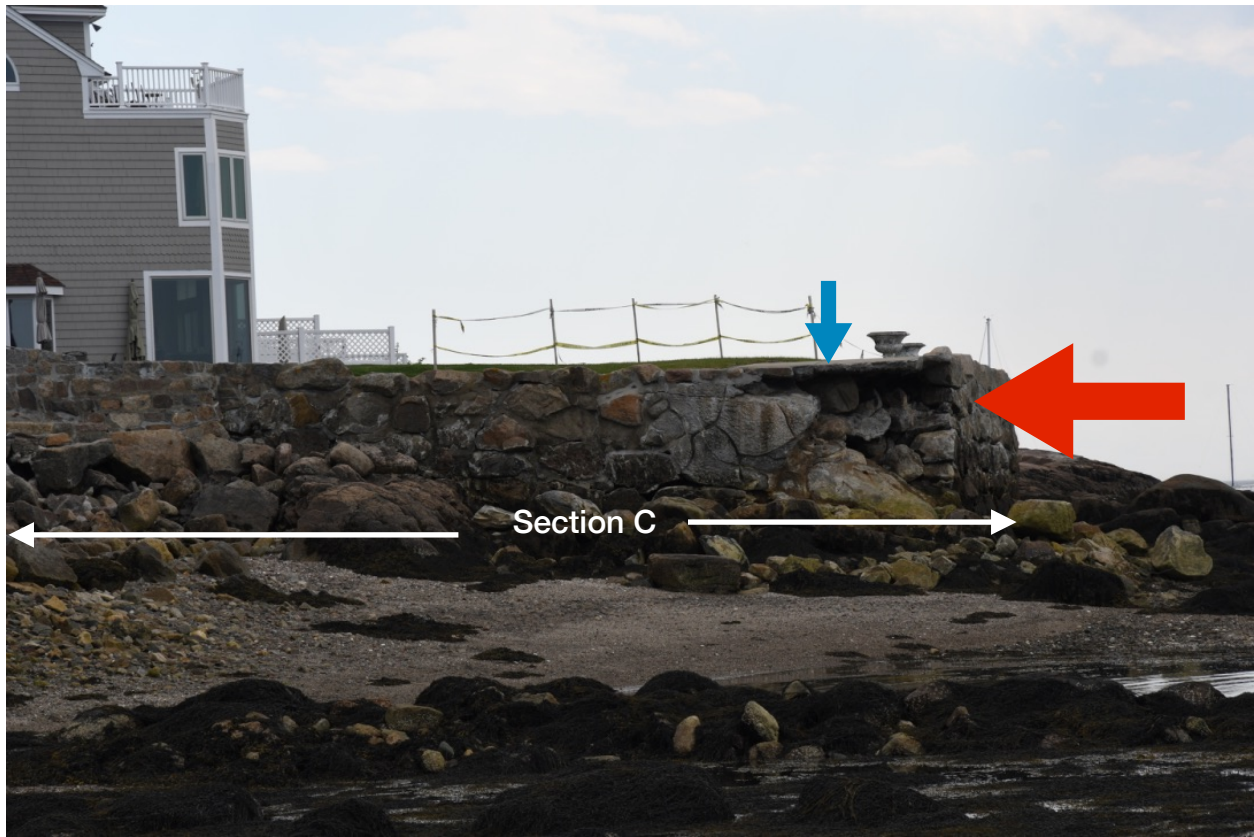
view of section C showing the failed corner just below the two urns

One area of concern is the portion of section A adjacent to the failed corner marked with a red arrow. The next photo shows a closer view of this part of section A starting from the failed corner.

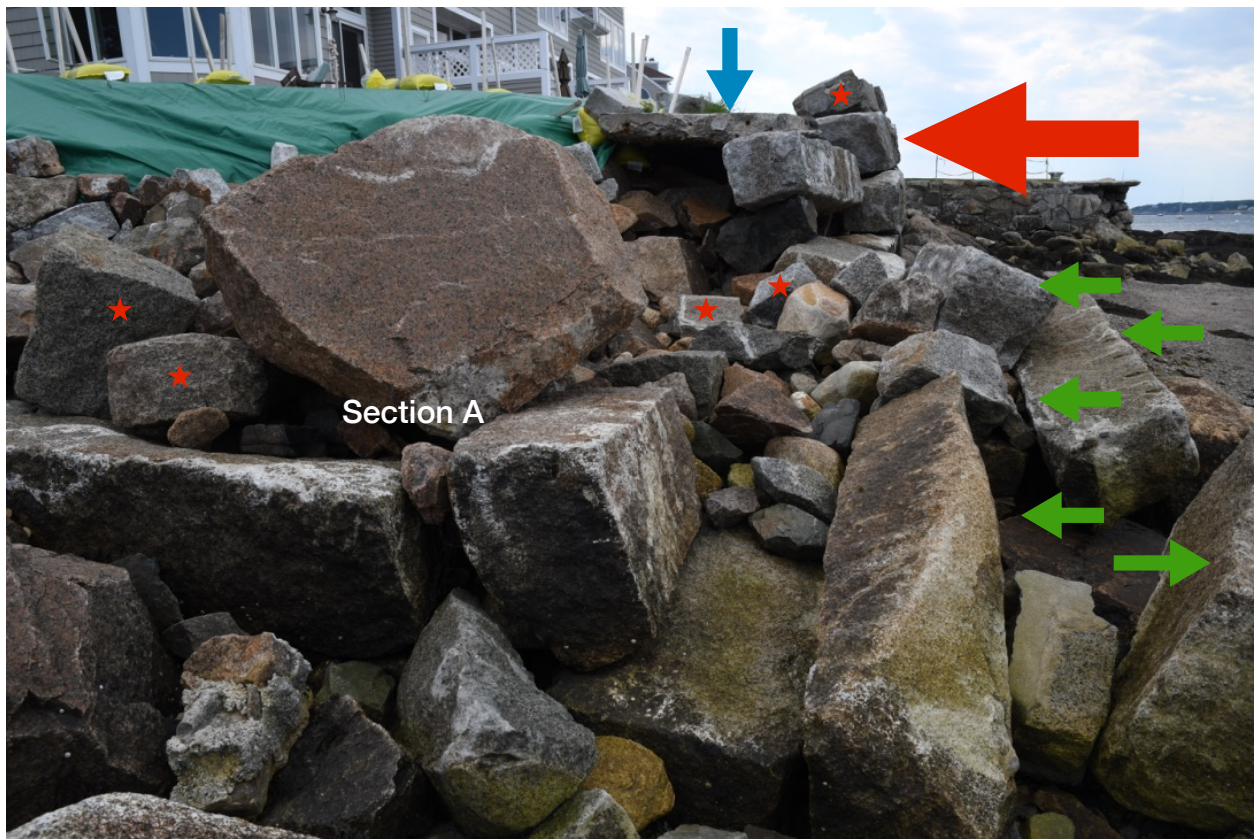
The red arrow indicates an uncollapsed portion of section A which appears to be buckling. The stones indicated with green arrows adjacent to the buckled portion of the wall fell in a pattern consistent with a buckling failure of the corner of the wall.

The photographs also provide information regarding the construction of the seawall. Blue arrows in the photographs point out overhanging slabs of cast concrete. The material of the seawall in this area must have been comprised of small to medium sized stones or rubble, since large stones would have resisted being washed away. There is no evidence of a systematic structure behind the facade of large dressed stones (here “dressed” means chiseled/split/finished to have flat and fitted surfaces).

The closeup view of open corner also reveals the complete absence of large dressed stones in the interior of the structure. There are some smaller dressed stones marked with red stars which appear to have fallen into the structure from the very top of the wall. One stone at the top of the wall also marked with a red star demonstrates the likely course for these fallen smaller stones. Otherwise, there are no dressed stones within the structure.

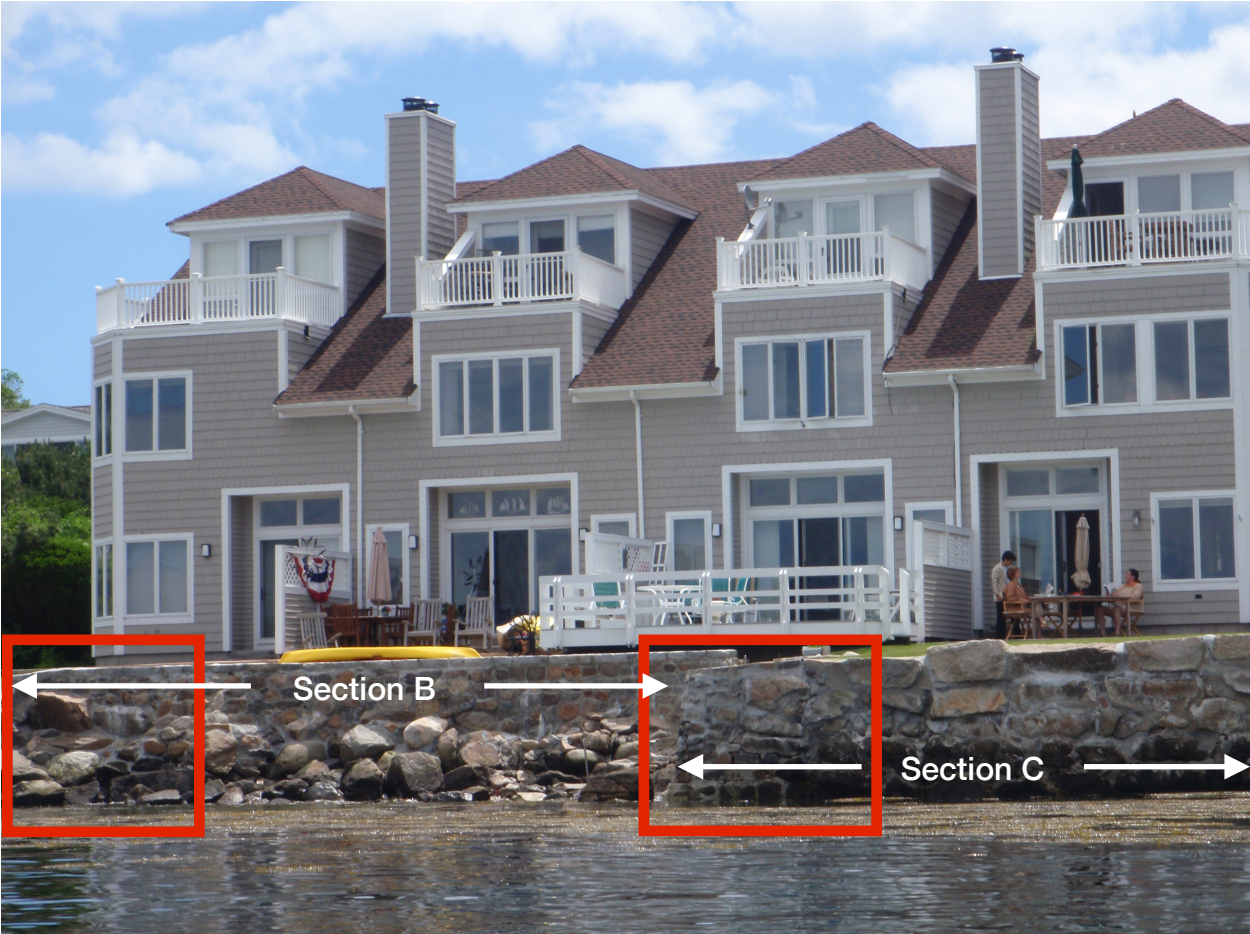
The photo at the bottom of this page, taken June 30, 2011, provides some historical context for the current masonry failures. The red boxes indicate the approximate locations of the insets on pages 10 and 11.

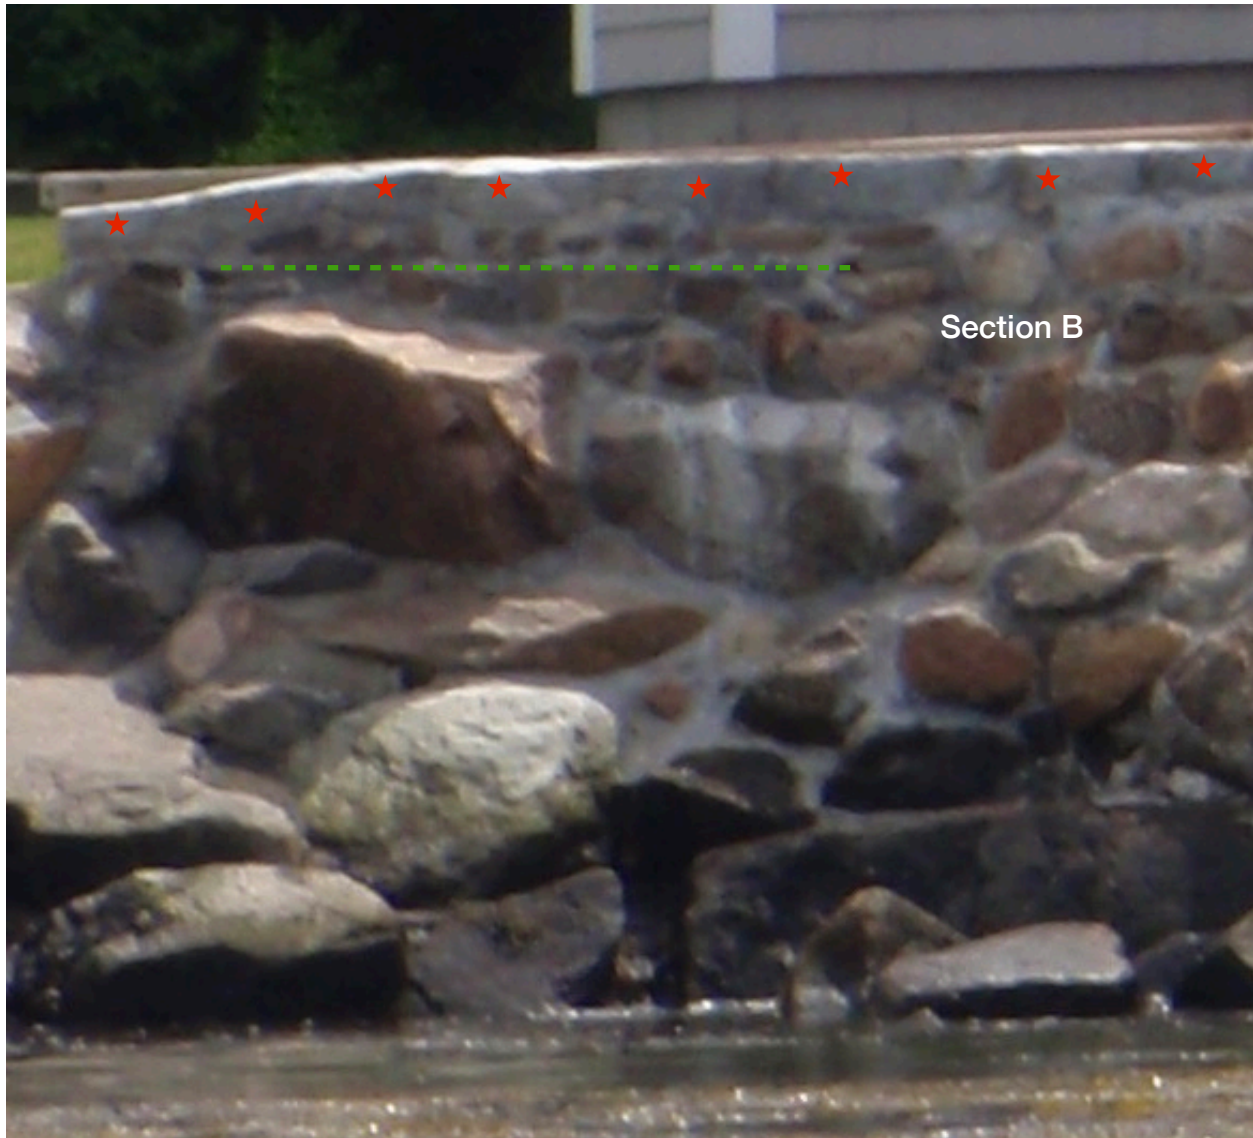
The leftmost inset on page 9 is expanded here to show a detailed portion of section B.

The top of the wall uses small dressed stones (marked with a red star) to cap a structure comprised of irregular stones mortared together. The masonry in this part of section B is somewhat irregular. The green dotted line indicates one possible course, but much of the masonry in the right side of the image consists of undressed stones mortared together irregularly. This is typical of rubble masonry.

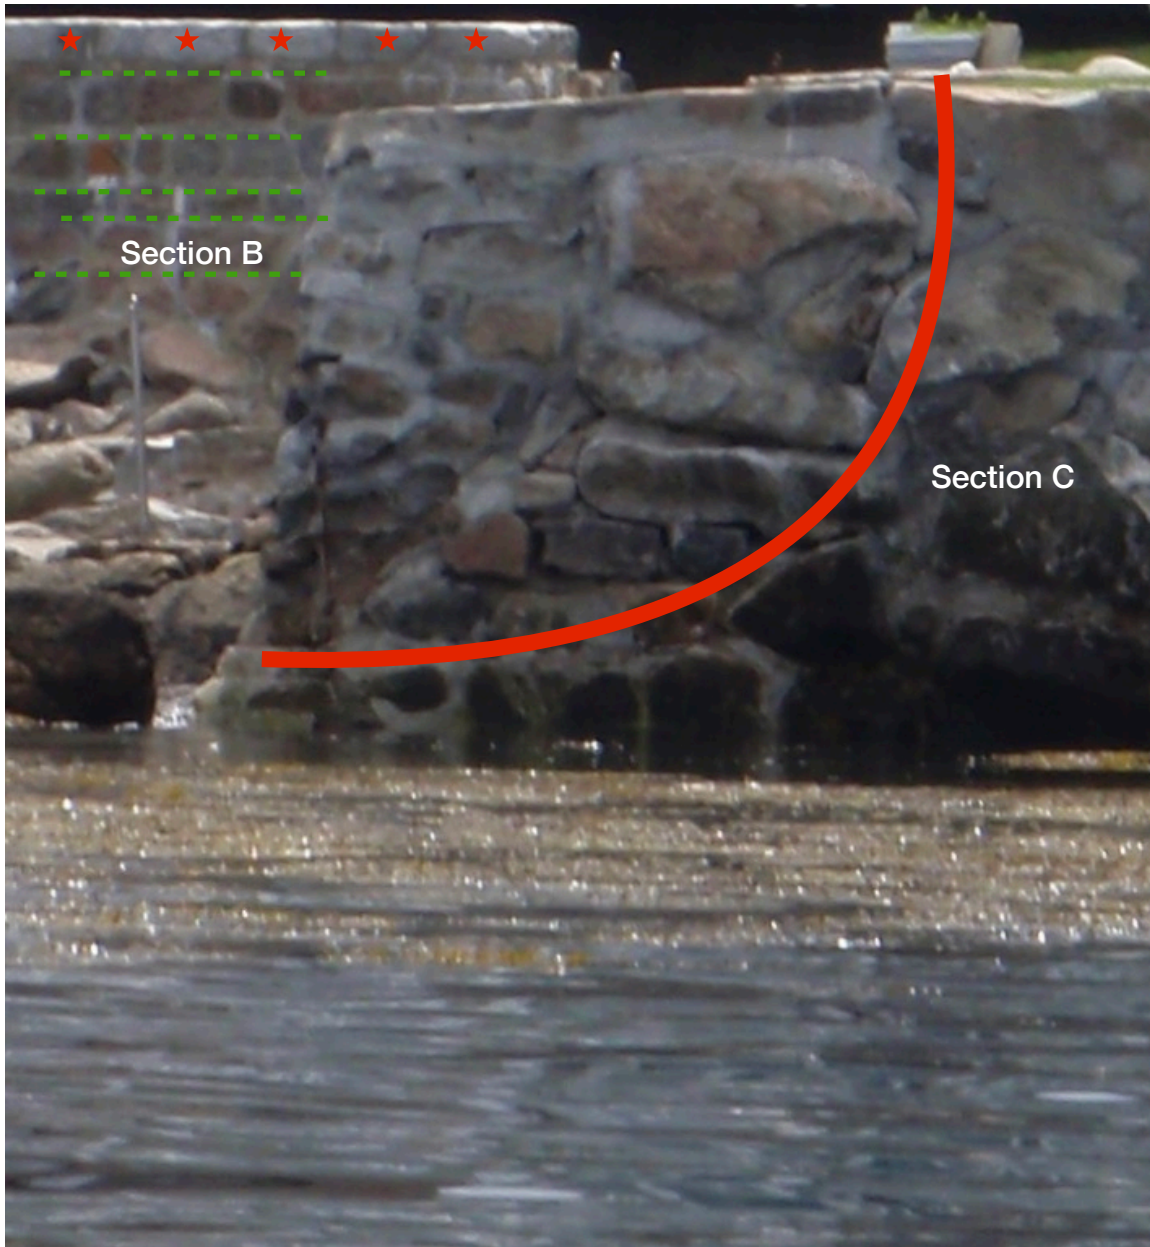
The right inset on page 12 shows the rightmost portion of section B along with the corner in section C which failed in 2018.

Comparing the right and left portions of section B, notice that the construction of the righthand portion of section B uses much more regular stone than in the previous photograph. The capstones (red stars) are similar, but the structure underneath is much more regular, showing some evidence of regular courses (green dashed lines). The heterogeneity in Section B also suggests construction and subsequent repair work use a variety of masonry techniques, probably at different times. Rubble

masonry capped with dressed stone would present the appearance of a solid wall to a pedestrian observer, concealing the rubble masonry construction below.

The red arc highlights the corner of section C which has now failed. Notice the irregular small stones mortared together, along with the line of mortar cracks just inside the red arc. Use of rubble masonry to reconstruct the corner suggests a patchwork repair was employed, and limited attention applied to prevent subsequent failure.

This recent photographic evidence highlights the variety of masonry techniques employed in the wall. The seven year old image shows that failure of the corner in section C had occurred in the past and had been repaired with methods and materials distinct from the surrounding wall; unfortunately, these patches appear to provide little longevity.

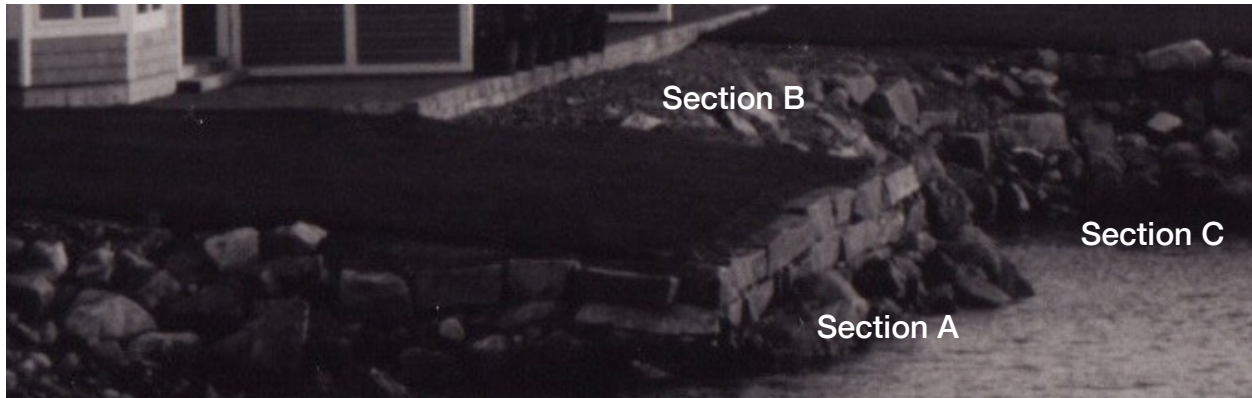
Section A lacks the capstones from more recent photographs (and the current conditions). Section A may also have an additional course of dressed stone; there is some difficulty in reconciling the dressed stones in the images.

Section B was more of a revetment than a wall in 1982. The slope of the revetment ends near the edge of the brick patios. Note that when the 1900 plan drawing is superimposed on the current engineering drawings, the edges of the brick patios are consistent with the 1900 line marked "Wall". (see green arrow on the next page).

Section C is also more of a revetment or a previously collapsed wall than in current conditions.

This photograph establishes that significant changes and rework have been applied to the seawall since construction of the condominiums.

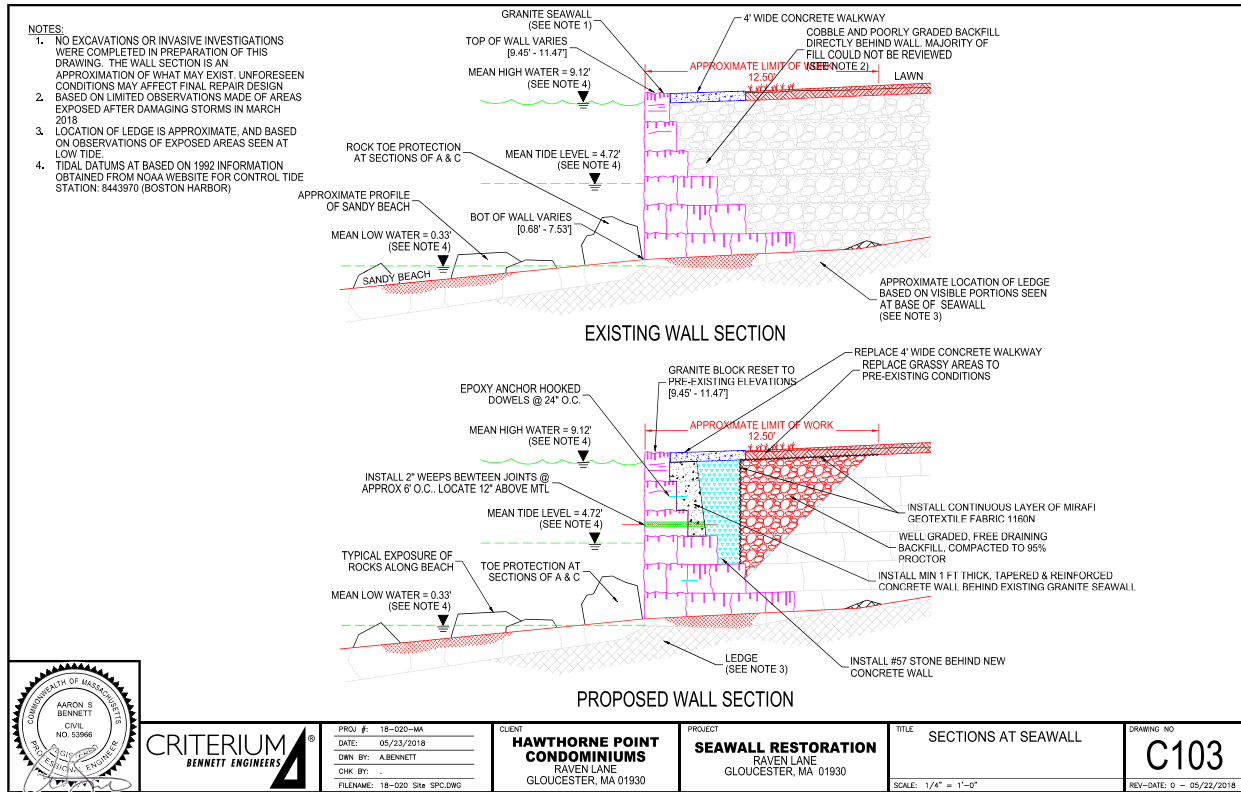
Drawing number C103 in the NOI illustrates these parameters. Note number 1 disclaims the accuracy of existing wall cross section:

“No excavations or invasive investigations were completed in preparation of this drawing. The wall section is an approximation of what may exist. Unforeseen conditions may affect final repair design.”

The response given was “No”. This is internally inconsistent with the drawing C103 shown in the previous section. The drawing shows the majority of the damaged structure is below mean high water.

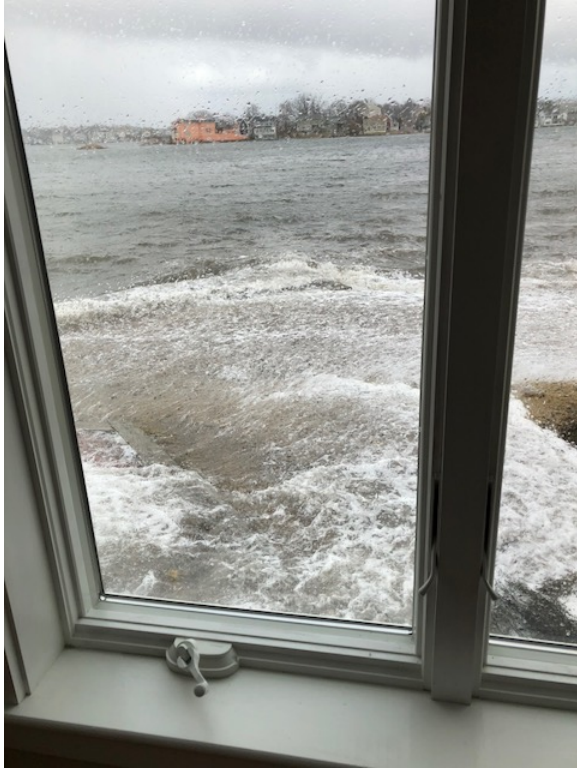
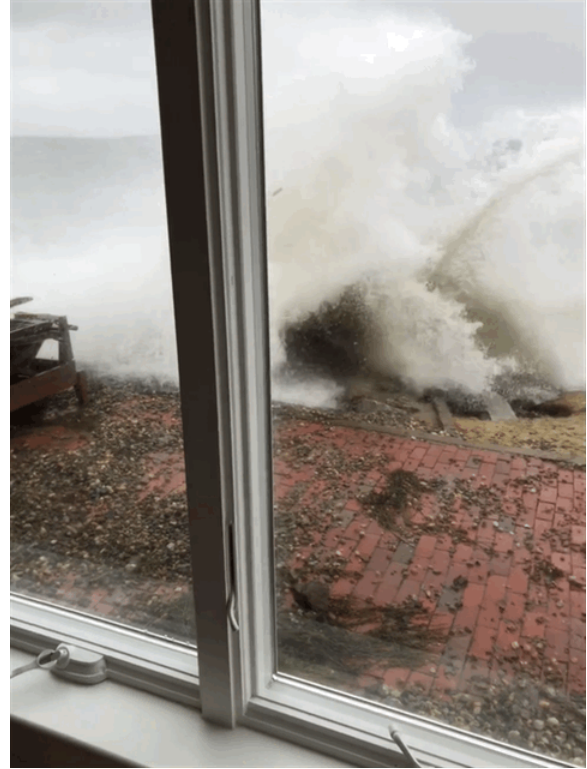
This picture on the left taken during the March 2018 storm clearly shows the water level completely inundating section A. Notice that the surface of the water in this picture is relatively flat. Drawing C102 indicates the high point on the brick patio is approximately 11.76 feet, so this storm surge appears to have been approximately 12 feet above mean low water.

The relative calm during this period should be contrasted to the picture on the right taken when the tide was lower but wind and waves were more significant. Fortunately, the surge did not coincide with the wave action.

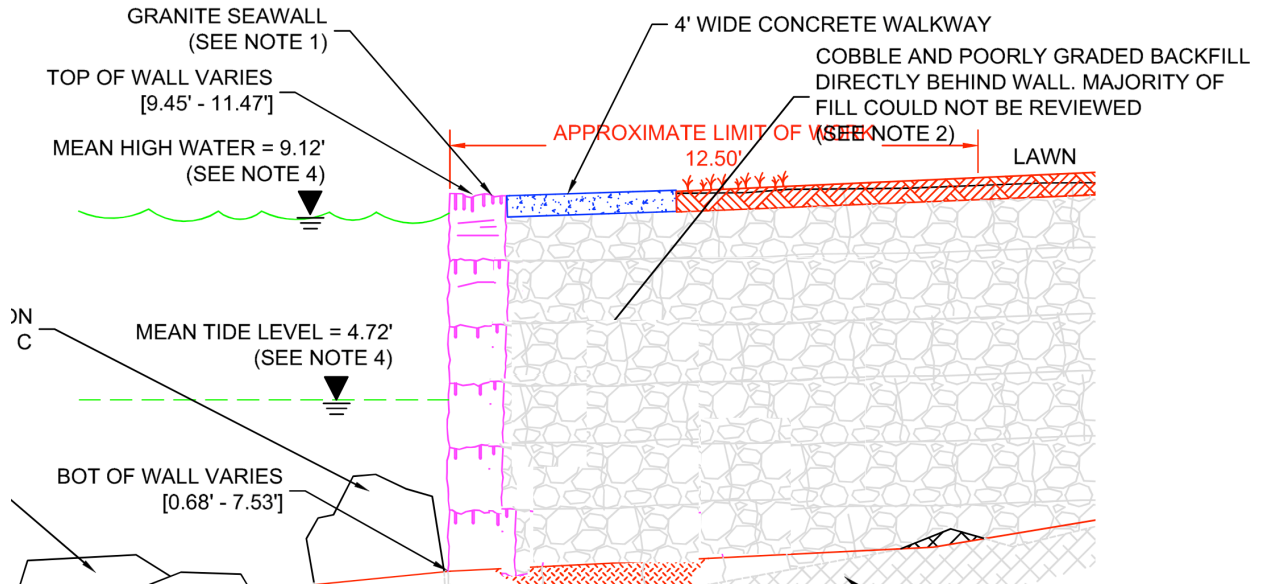
Should this figure more closely represent the existing structure, then “excavation ... to a depth where the thickness of the stacked granite block becomes greater than 5-6 feet from the face of the wall” will naturally lead to option 3, where the entire wall is deconstructed. The main difference relative to option 3 might be that after the structural concrete layer is installed, a facade of dressed stone is used to conceal the bulk of the concrete.

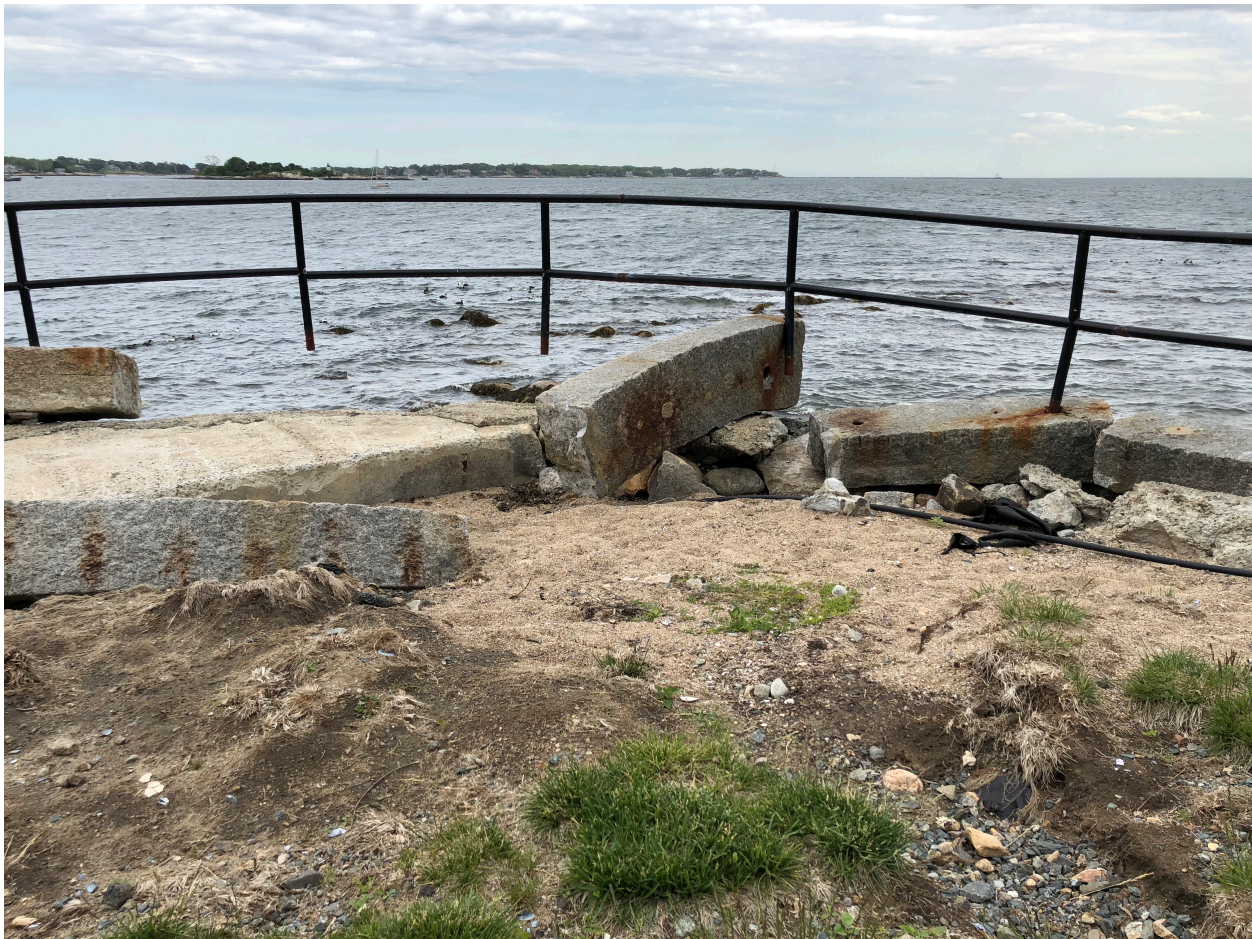
Despite drainage and fabric to limit movement of fines, overtopping water severely eroded the grassy area behind the seawall and displaced several large stones. This portion of the Stacy Boulevard seawall was the only section of the seawall not having a protective skirt covering the fill behind the seawall; the

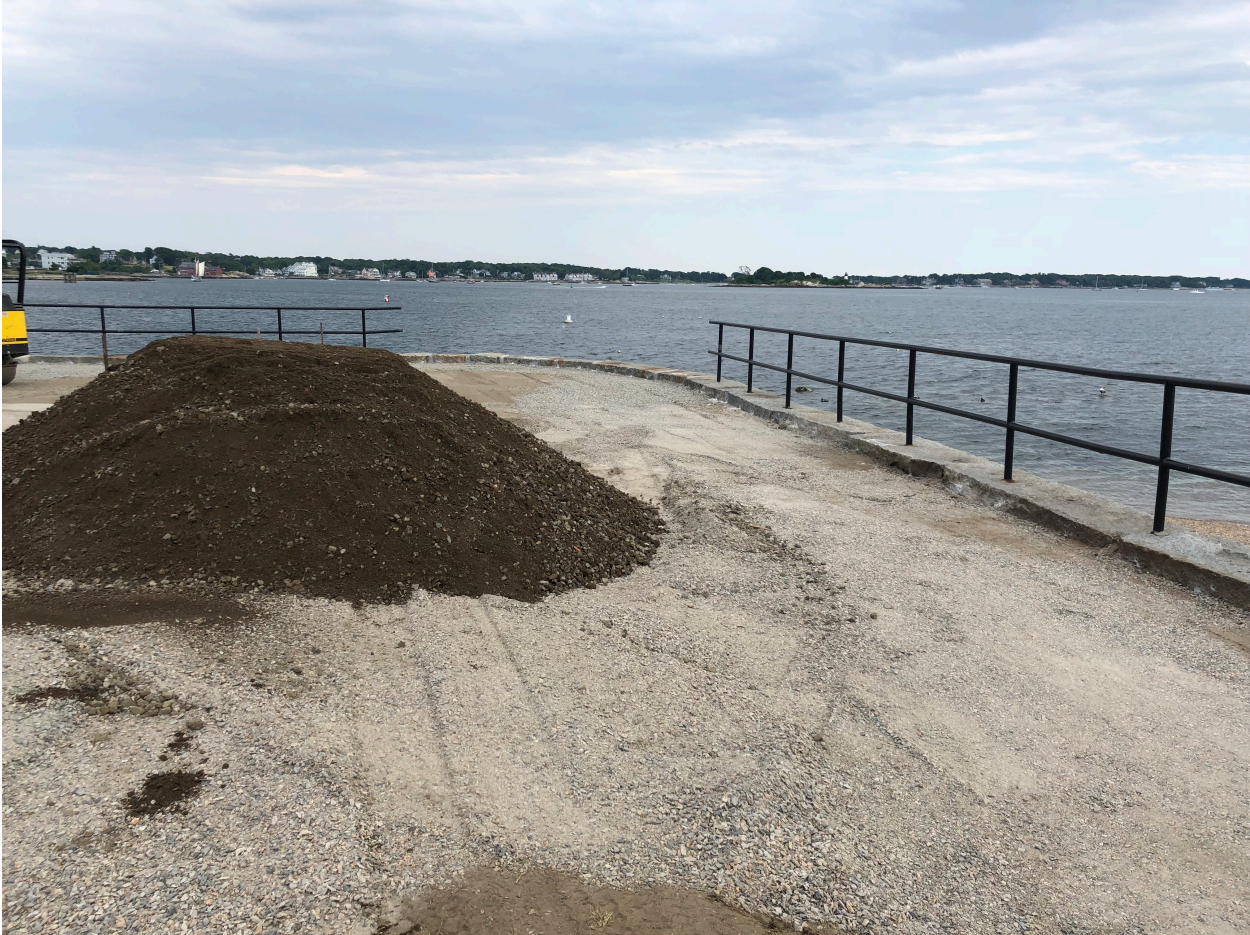
other half mile of seawall was not damaged. The following photo taken two weeks later (June 21, 2018) shows progress on the repair, with the large stones set into place, the handrail removed for replacement and the crushed stone underlayment being readied for pouring of a concrete walkway (the skirt).
