The Seawall at Hawthorne Point

This report will review what is known about the seawall at Hawthorne Point. By exploring the history of the seawall, this report expresses the author's opinion that the currently damaged seawall requires reconstruction from the bedrock ledge. This report also critically examines the Notice of Intent (NOI #028-2597) and the Seawall Rehabilitation Study, rebutting key assumptions of option 1 and option 2 in the Seawall Rehabilitation Study.

During the storm of March 2, 2018, the existing seawall sustained significant damage. The essential engineering components of the Notice of Intent (#028-2597) contain sufficient contingencies that the regulatory process may not suffer significant disruption, assuming that prompt corrective action gets applied to the restoration plans.

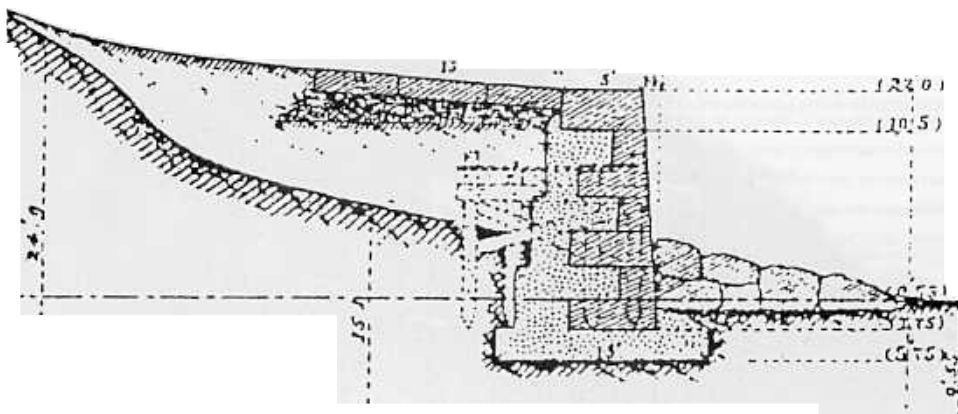
Fig. 10. Cross-section of seawall on Gallops Island, Boston Harbor, constructed in 1870 of concrete with facing of dressed granite

This 150 year old design lacks a few key elements. From the drawing, one cannot see how any water penetrating the fill behind the seawall can escape. Seawalls should not be dams; the problem of controlling wave action and tides is a big enough problem.

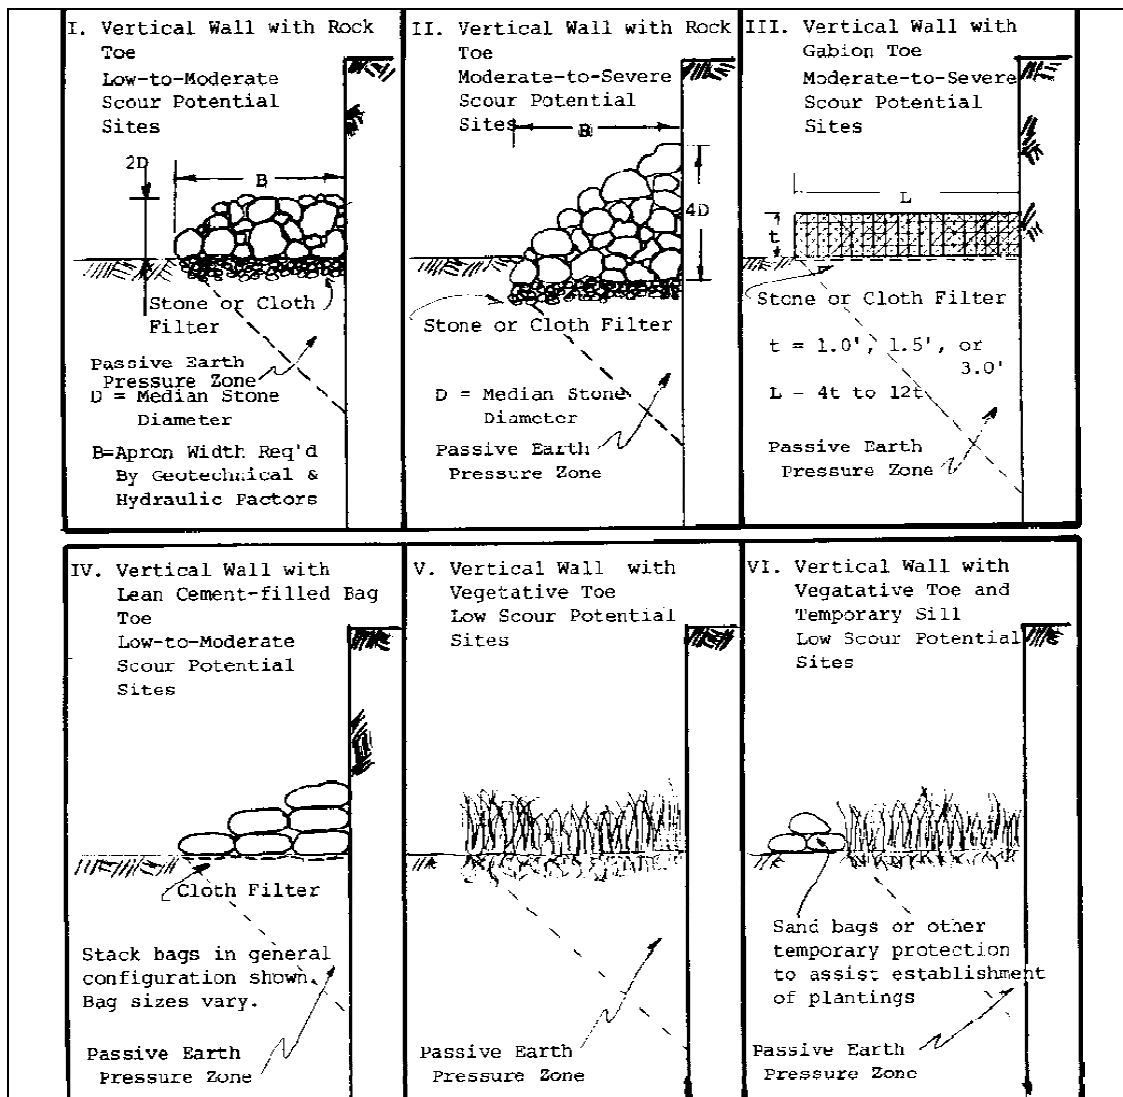
Figure 2-5. Seawall and bulkhead toe protection

The USACE-EM contains a figure that helps explain how seawalls remain standing. The triangle labeled “passive earth pressure zone” supports the wall against toppling forward. The figure shows various techniques for protecting the support structure from erosion or scouring by wave action.

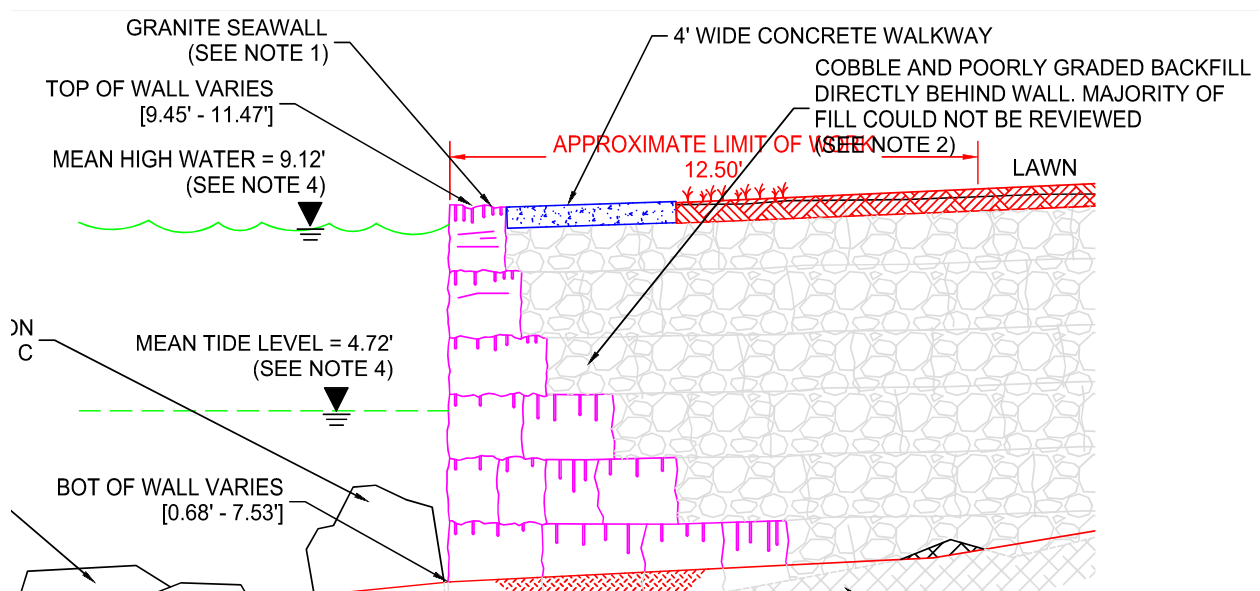
The key contingency in the NOI is that “excavation is only anticipated to a depth where the thickness of the stacked granite block becomes greater than 5-6 feet from the face of the wall”. Thus option 1, option 2 and the work proposed by the NOI are all predicated on the existence of a seawall cross section as shown in drawing C103, the key inset shown here. Notice the increasing thickness of the wall with depth. This is not consistent with the current conditions detailed in the first section of this report.

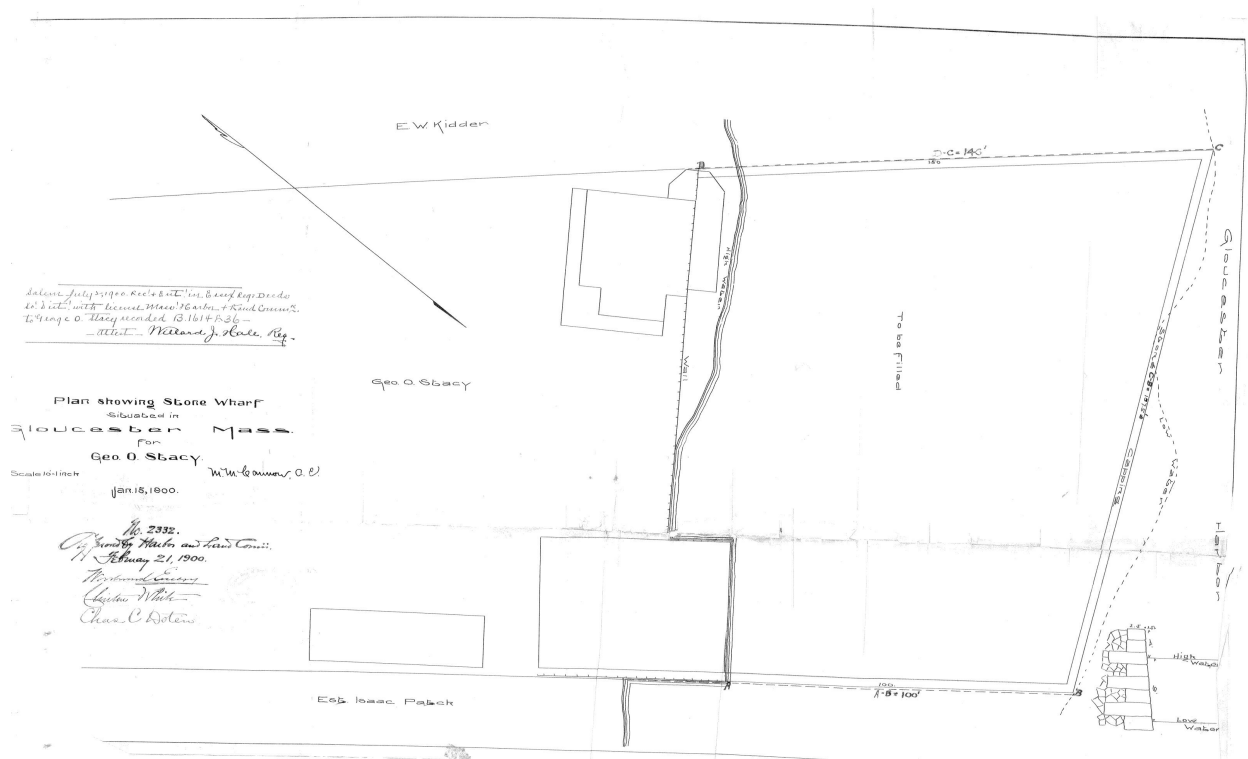
Note that this plan drawing shows a pre-existing seawall in the same location as section A. The license granted George Stacy the right to construct a structure extending to the low water line. The drawing also shows the expected cross section of the proposed seawall. There is another wall indicated parallel to the current section B, but section C is missing entirely.

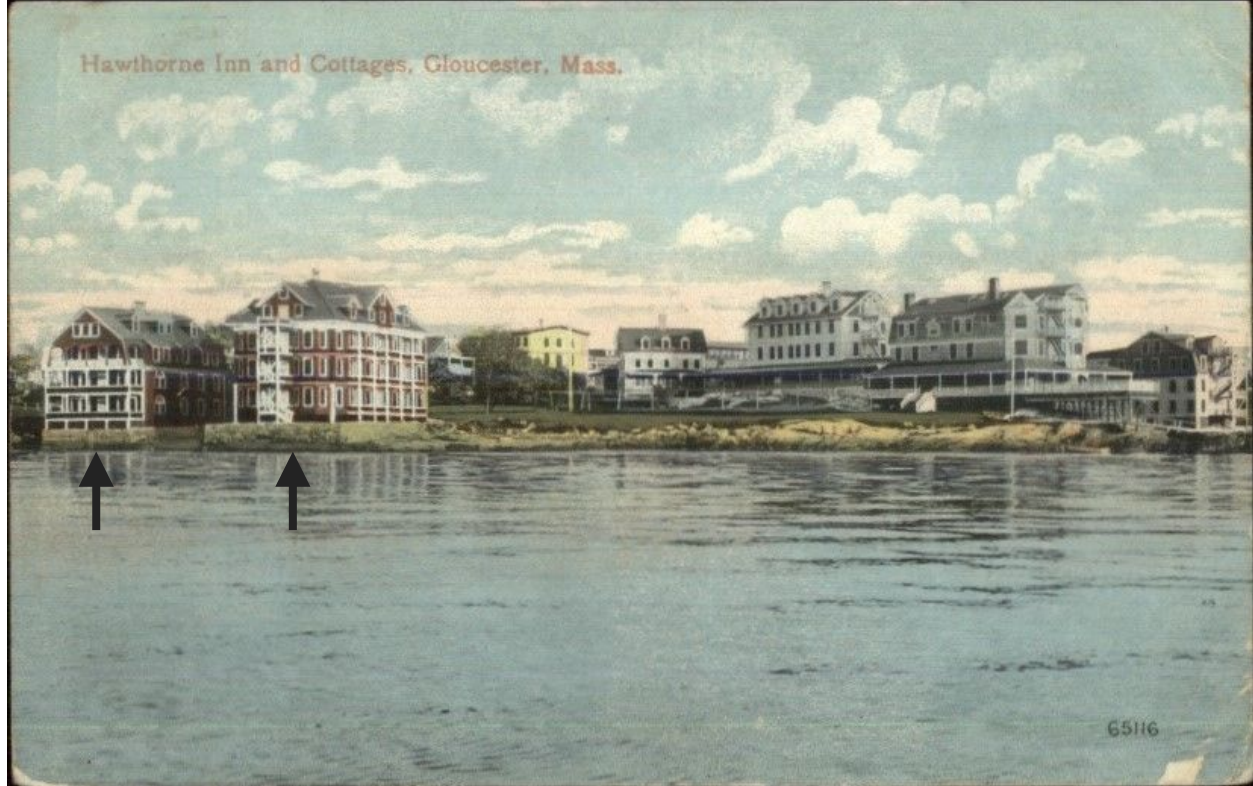
This proposed structure was apparently never implemented. Postcards of the Hawthorne Inn circa 1910 show a cottage on section A (left black arrow), and another cottage on section C (right black arrow). No license is recorded for the seawall in section C. All deed transfers of the property after 1900 make no mention of any seawall license. As the discussion regarding license 551 will show, this omission is not due to George Stacy's or his widow Jane Stacy's lack of awareness of the value of such a license.

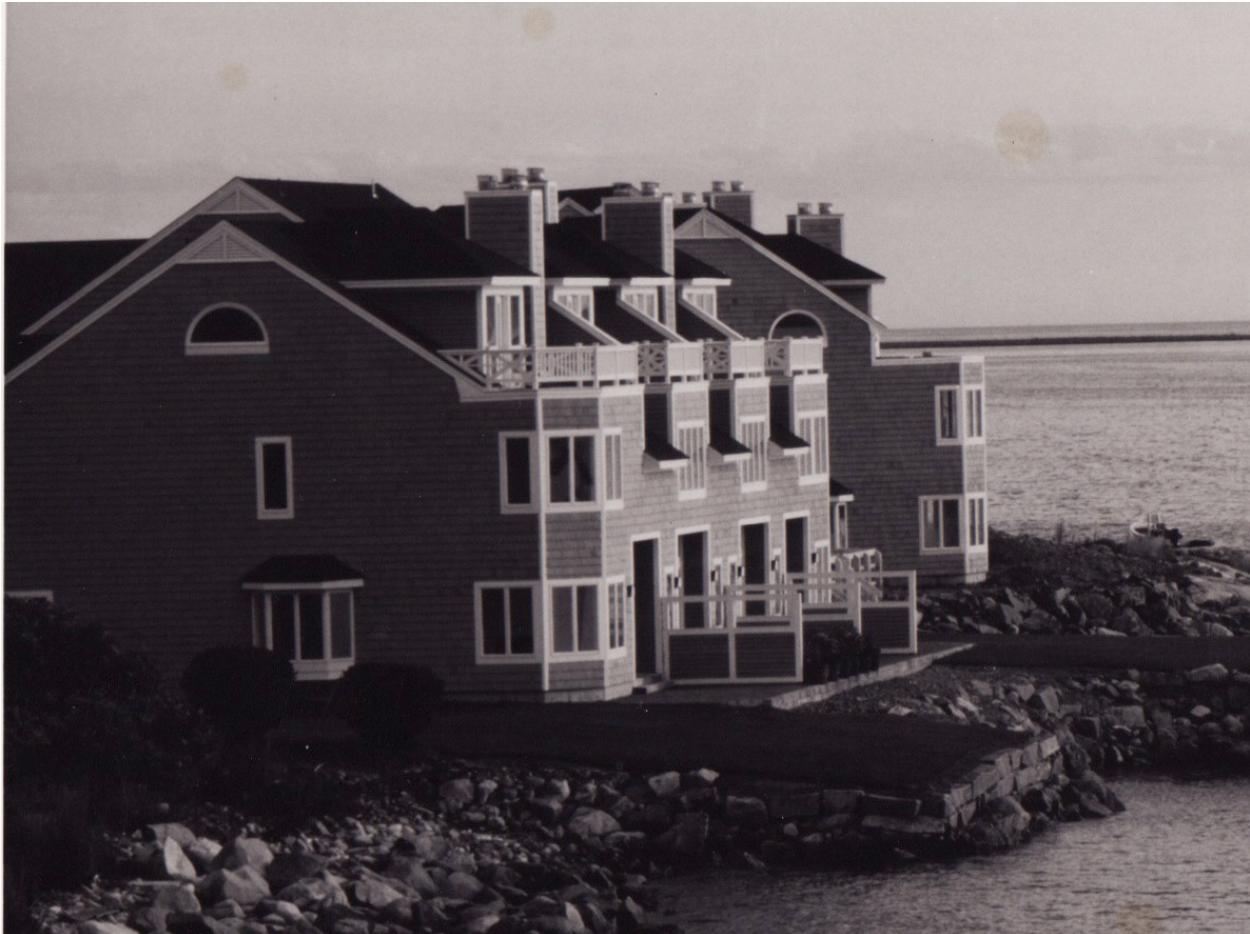
Second, while portions existing seawall were probably constructed in the nineteenth century, the existing structure has changed extensively over the past century, and even over the past 35 years. As noted in
